Derby 172 **(RC 8472)**

Chassis:	Sunbeam W4
Chassis No:	50088
Motor:	British Thomson-Houston
Bodywork:	Weymann UH30/26R
Body No:	C8014
Length:	26ft
Width:	7ft 6in
Unladen Weight:	
Entered Service:	1944
Withdrawn:	1964
Owner:	The Trolleybus Museum at Sandtoft

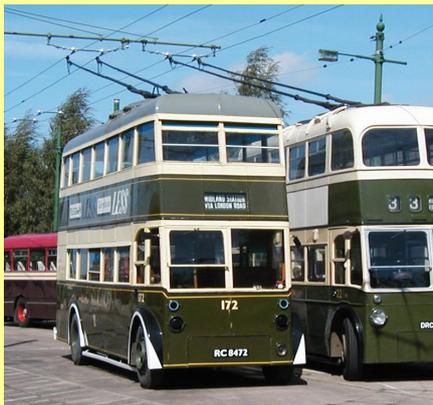
Features of Utility buses are the "single skin" panelling (ie the reverse of external side and roof panels are visible inside the bus) and the "shell-back" rear roof dome, made of flat steel sections instead of a curved panel-beaten fitting. Other features of the Utility design were
